# Arboricultural Report

Tree Survey,  
Arboricultural Impact Assessment &  
Arboricultural Method Statement

**Lands at Cartron  
Oranmore  
Co. Galway**

**230827-PD-11**

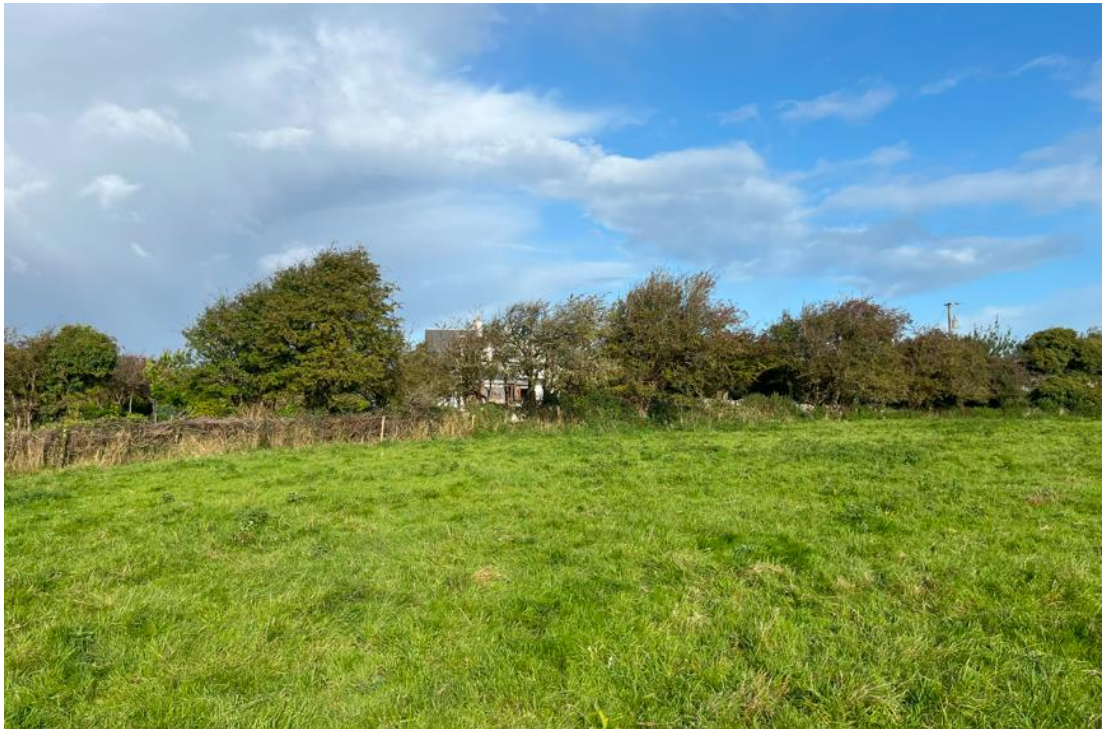
**Image 1:** View of the remnant hedgerow (T606 to G613) located adjacent to the western boundary.

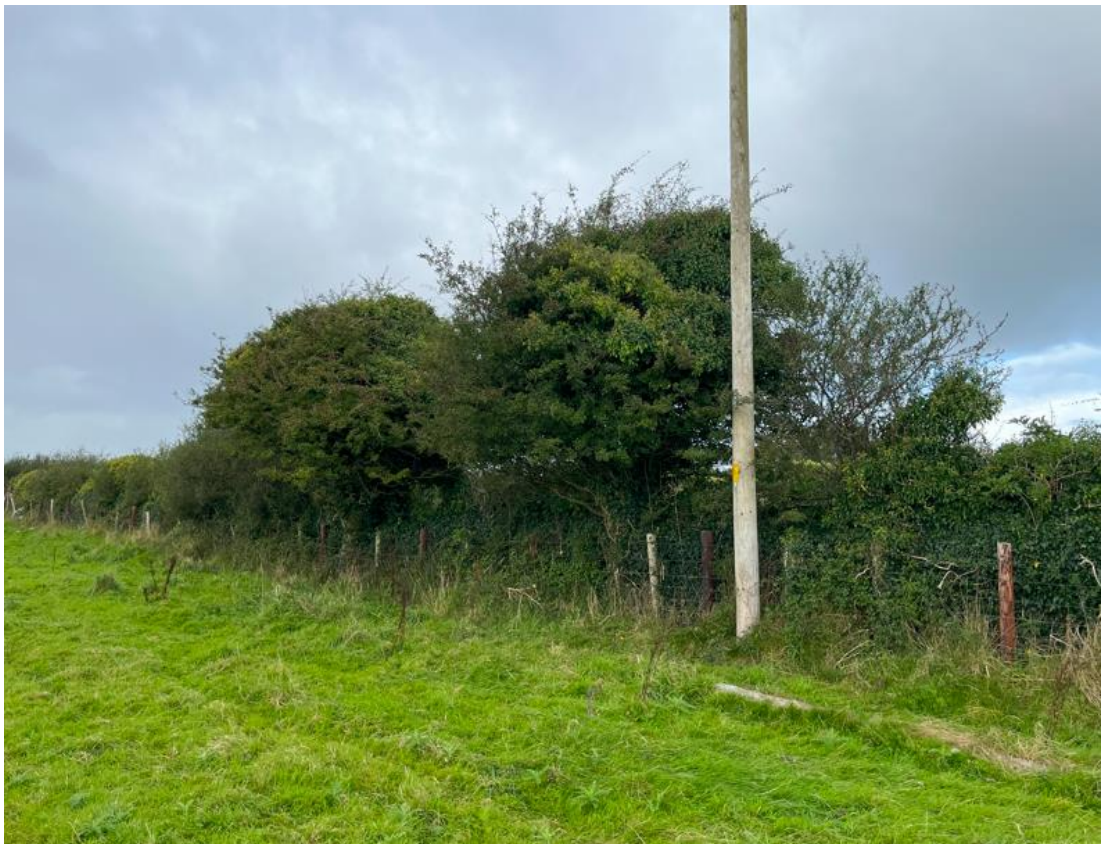
**Image 2:** View of the two hawthorn trees T535 and T536 located adjacent to the northern boundary.

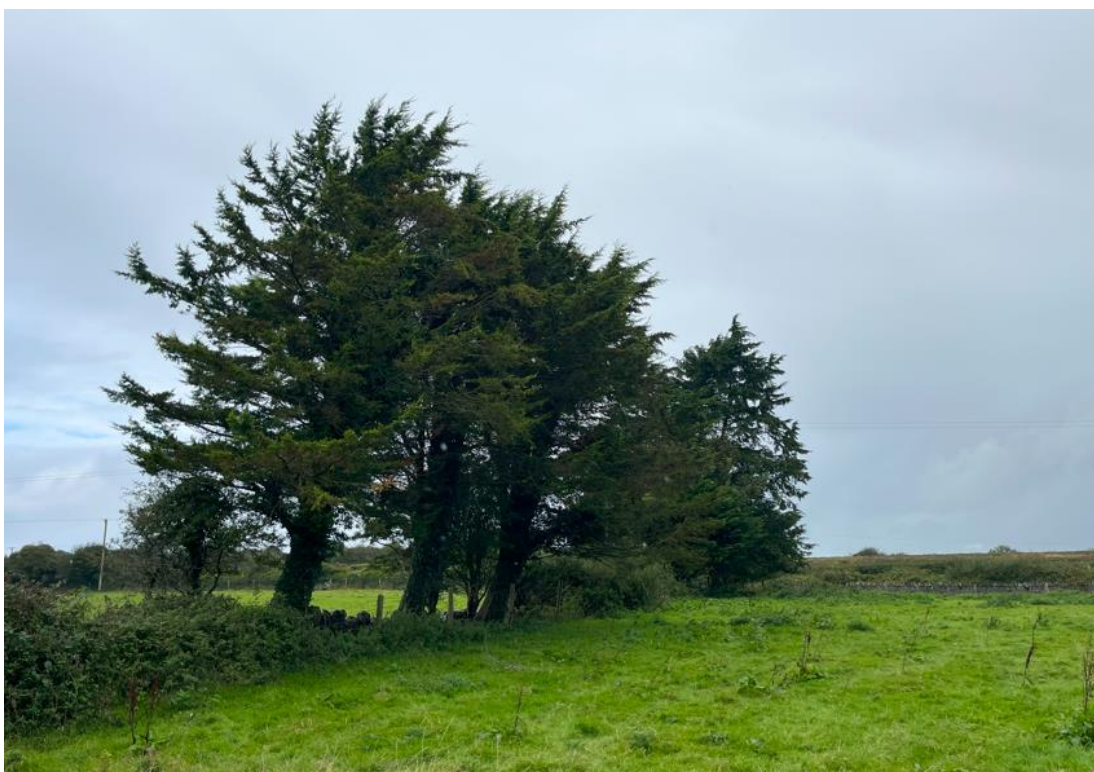
**Image 3:** View of the central tree and hedgerow which includes several Leyland cypress with blackthorn and bramble (T537 to T544).

Tree T543	1 x Cupressocyparis leylandii (Leyland Cypress)	12.0	69	1	3.5		6.5		3.5		3.5		1.0		Mature	Structural condition Poor. Physiological condition Fair. Decay / structural defect - Bole. Ivy or climbing plant.	18/09/2023	215.4	8.3	0-10	U
Tree T544	1 x Cupressocyparis leylandii (Leyland Cypress)	10.0	69	1	3.5		5.0		3.5		3.5		2.5		Mature	Structural condition Poor. Physiological condition Poor. Die-back - Throughout crown. Decay / structural defect - Extensive. Decay / structural defect - Bole. Ivy or climbing plant.	18/09/2023	215.4	8.3	0-10	U
Tree T545	1 Acer pseudoplatanus (Sycamore)	15.0	64	1	5.5		9.0		4.0		6.0		1.5		Mature	Structural condition Fair. Physiological condition Good. Competition - Adjacent trees.	18/09/2023	185.3	7.7	20-40	B2
Tree T546	1 Acer pseudoplatanus (Sycamore)	12.0	35	1	2.5		6.0		2.5		4.5		2.0		Early Mature	Structural condition Fair. Physiological condition Fair. Competition - Adjacent trees. Deadwood - Minor. Suppressed crown - Minor. Unbalanced crown - Minor.	18/09/2023	55.4	4.2	10-20	C2

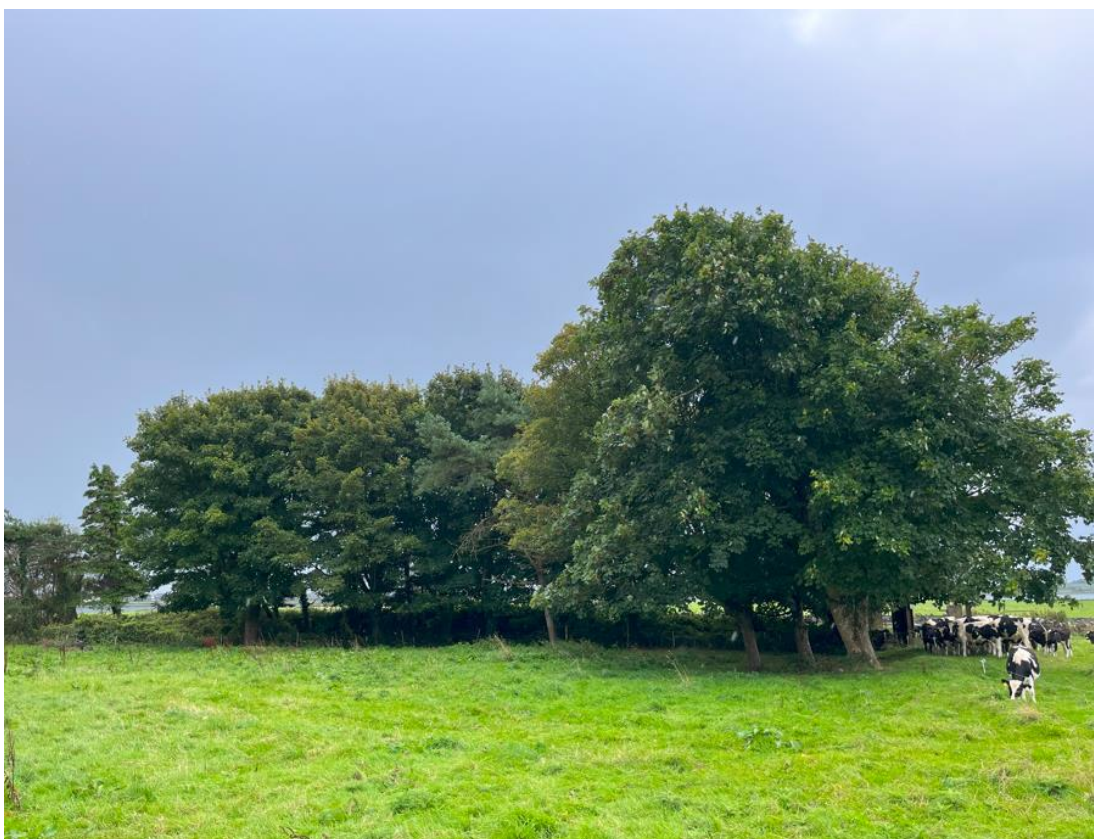
**Image 4:** View of the trees T545 to T563 located in the southeastern corner of the site adjacent to Coast Road. The group contains a mix of sycamore, ash, lawson cypress and pine.

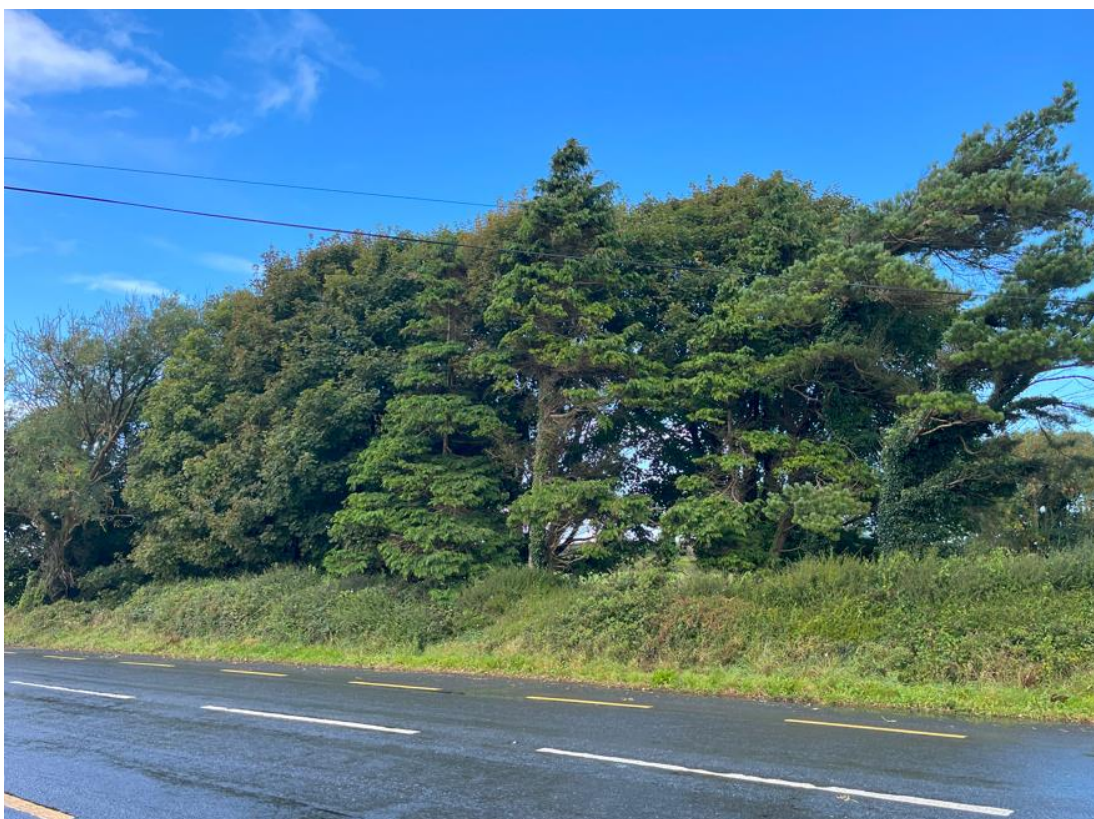
**Image 5:** Second view showing trees T545 to T563 in the southeastern corner of the site from Coast Road.

Tree T563	1 Pinus sylvestris (Scots Pine)	8.0	25	1	2.0		6.0		2.0		0.0		3.0		Early Mature	Structural condition Poor. Physiological condition Fair. Arboricultural work - Historic. Poor past pruning. Unbalanced crown - Major. Tree has been historically topped due to overhead cables.	18/09/2023	28.3	3.0	0-10	U

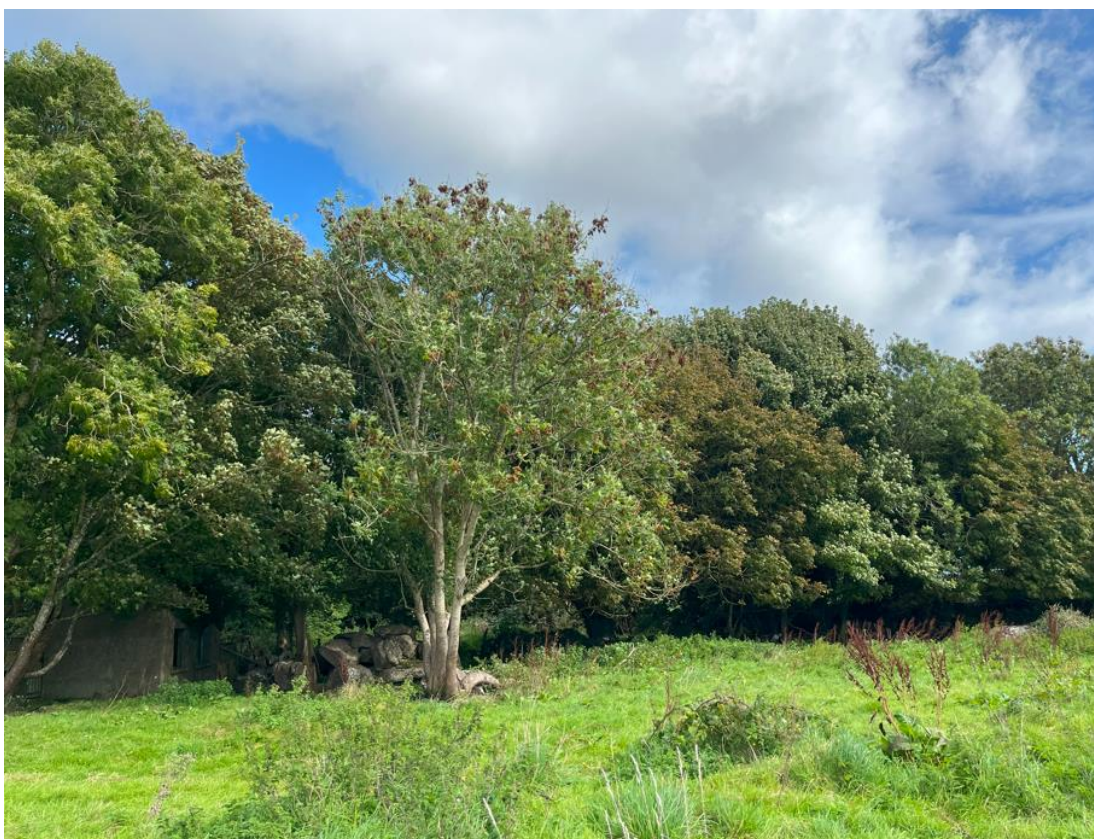
**Image 6:** View of the tree line T573 to T588. The quality of trees along this existing stone wall are of low and poor quality, many with significant structural defects.

Tree T577	1 Aesculus hippocastanum (Horse Chestnut)	13.0	47	1		12.0		3.0		4.0		4.0	0.0		Early Mature	Structural condition Poor. Physiological condition Fair. Coalesced decay seam - Suspected. Leaning trunk - Major. Pruning wounds - Decayed. Tree is infected with bleeding canker of horse chestnut.	18/09/2023	99.9	5.6	0-10	U

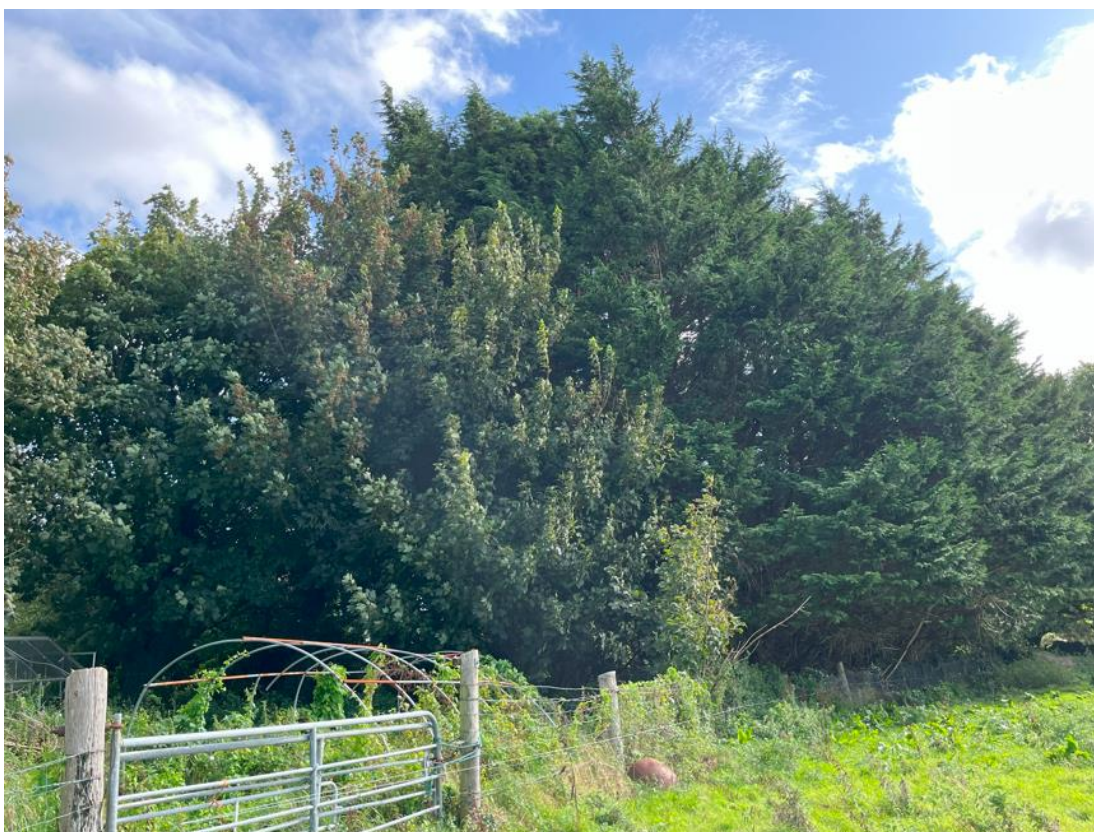
**Image 7:** View of the tree group G595. The majority of trees within this group are Leyland cypress.

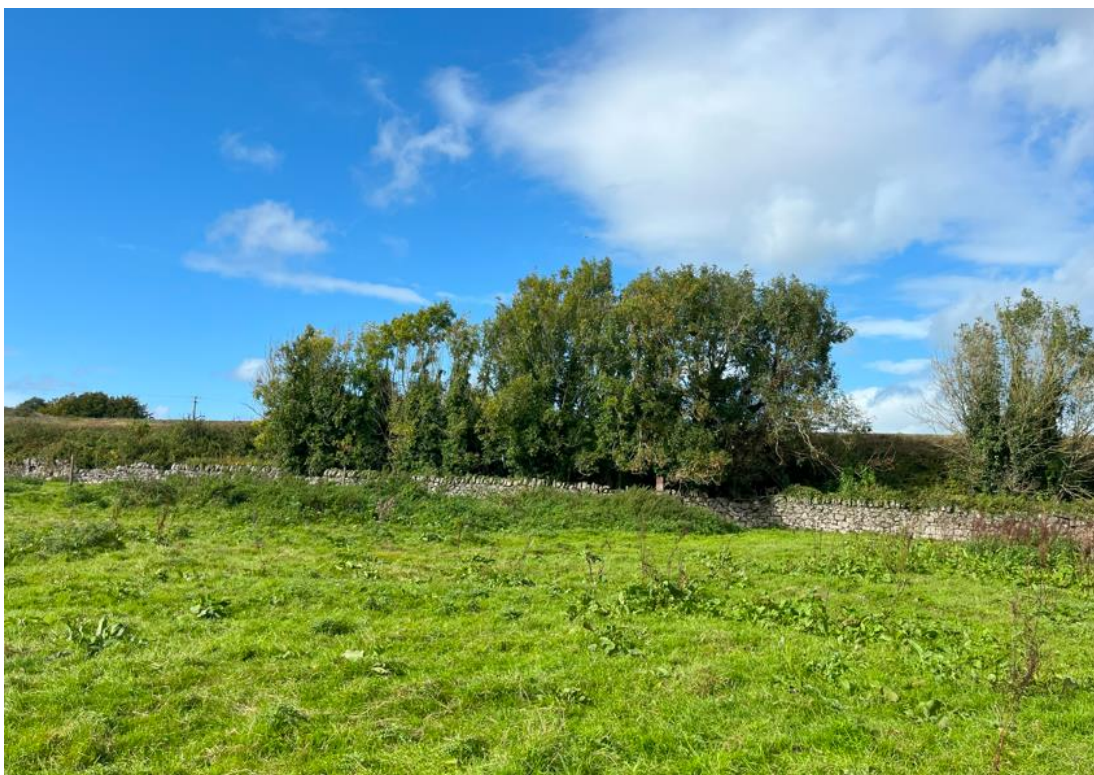
**Image 8:** View showing trees and shrub (G625 and G626) located between the northern boundary and railway line.
